⑥ OPERATION CROSSROADS.
U.S.S. ANDERSON (DD411)
U. S. GOVERNMENT AGENCIES MAY OBTAIN COPIES OF THIS REPORT DIRECTLY
FROM DDC. OTHER GOVERNMENT AGENCIES SHALL REQUEST THROUGH
Director
Defense Atomic Support Agency
Washington, D. C. 20301
TEST ABLE [4].

OPERATION CROSSROADS

BUREAU OF SHIPS GROUP
TECHNICAL INSPECTION REPORT

USS ANDERSON (DD 411)

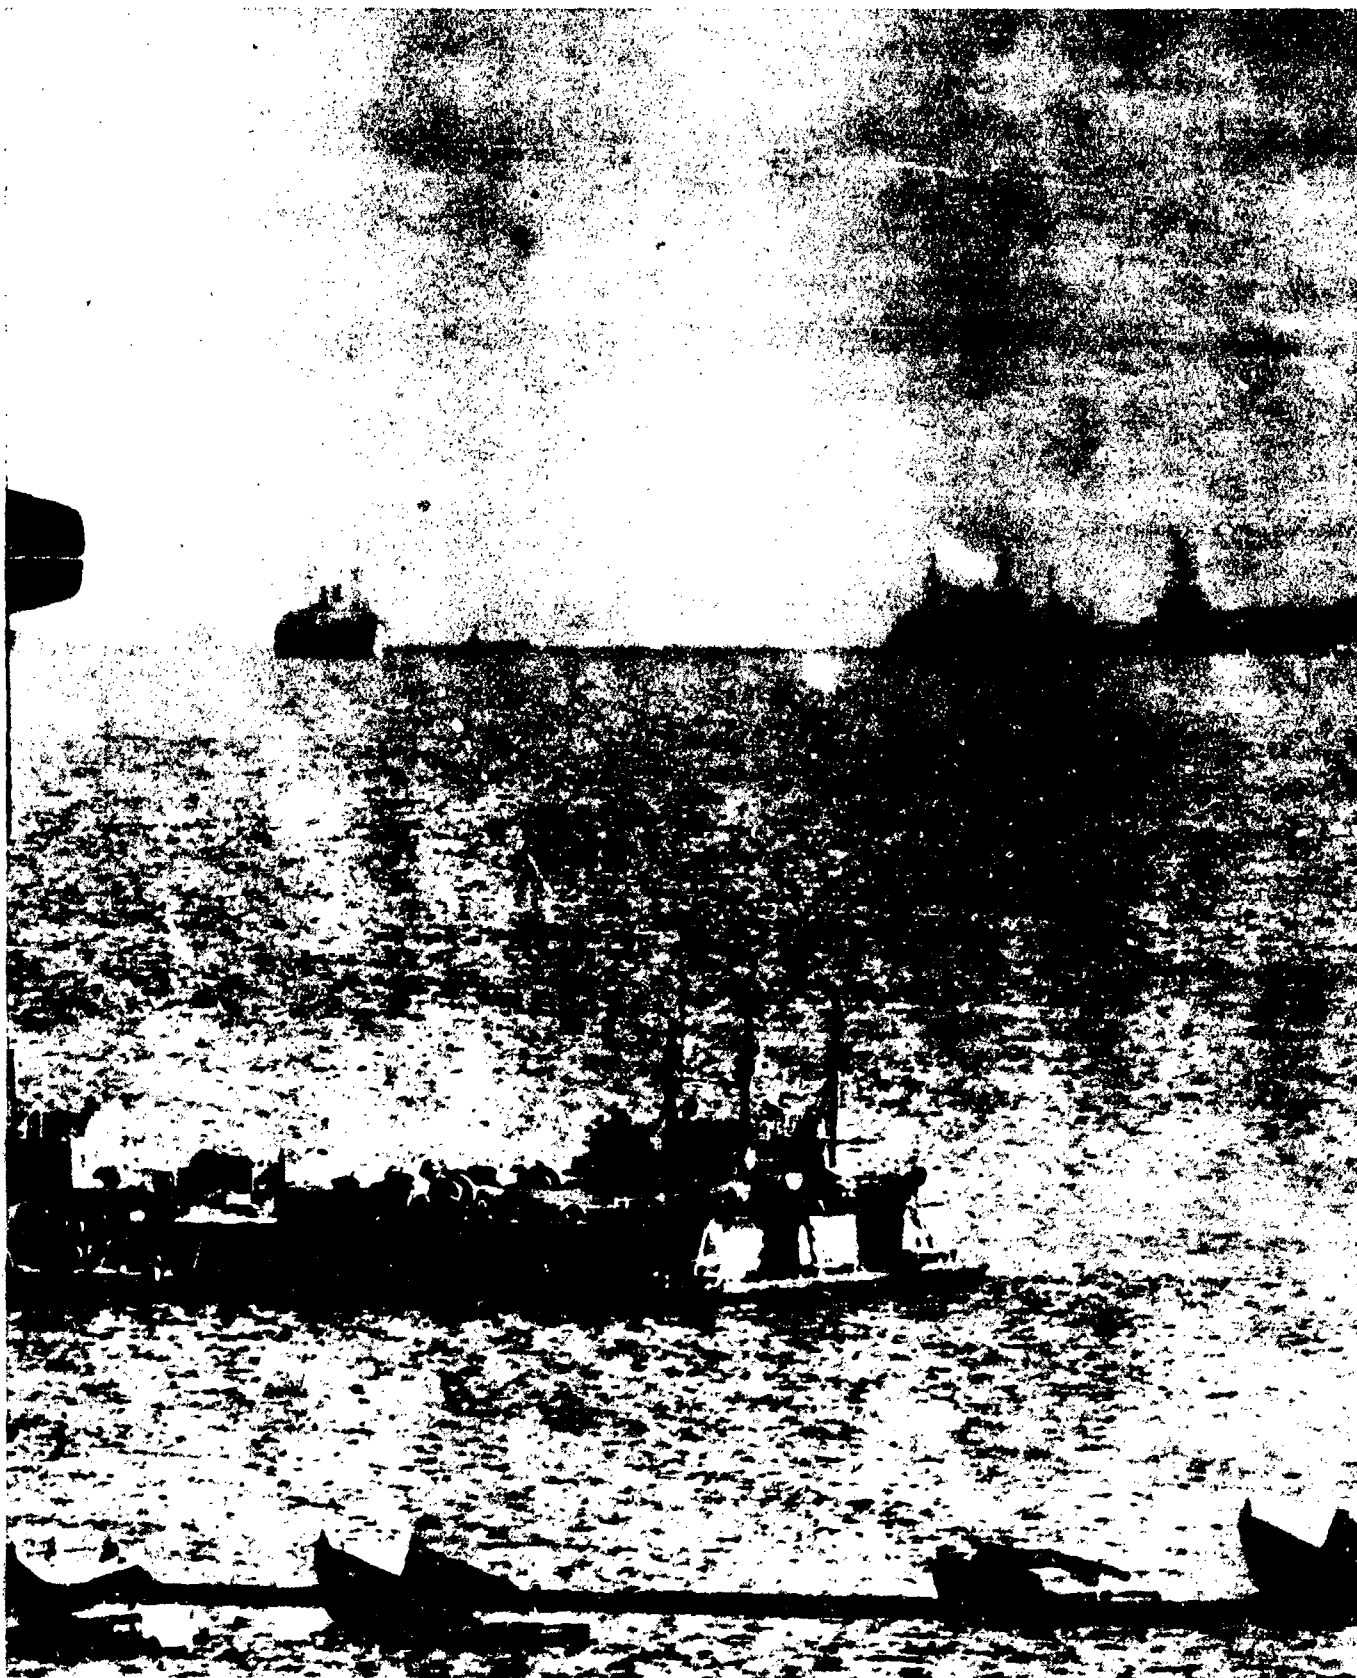
DA-CR-T3A-31-79/ (-11) 1 July 46/40"/Bikini/Secret. Print #57. Turn of the bilge is seen as capsizing is completed burst plus 2 minutes 51 seconds.

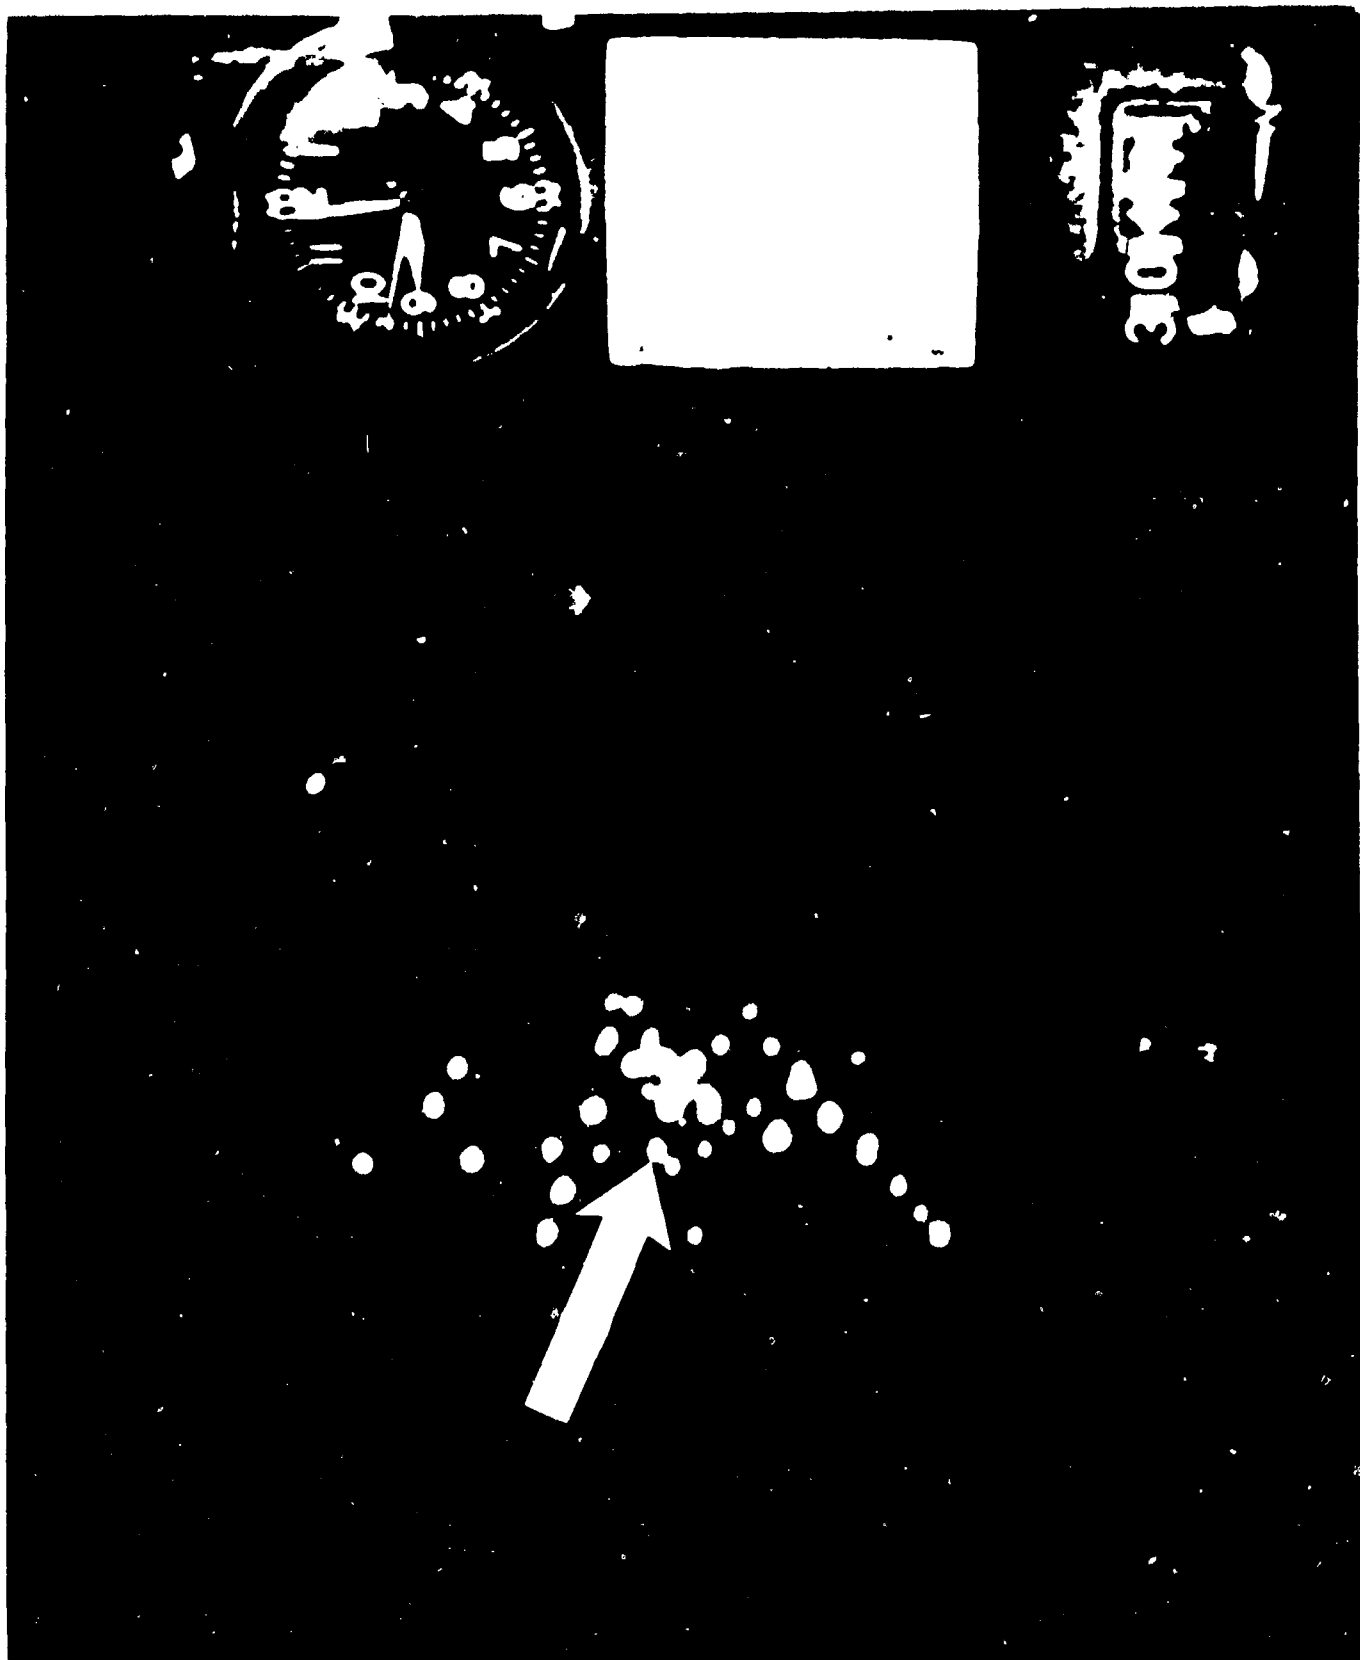
Photos, Page 26, and Page 27, are of the array as seen on an APQ-7 radar scope. In photo Page 26, the ANDERSON is seen just above the arrow. Photo Page 27, burst plus 2 minutes 38 seconds, is the first frame without an ANDERSON pip. This time corresponds with the capsizing of the ANDERSON, not her sinking.

APQ #7 radar scope photo #3011. View of radar scope taken 3/4 second before blast. Note position of ANDERSON (see arrow) and compare with photo page 27.

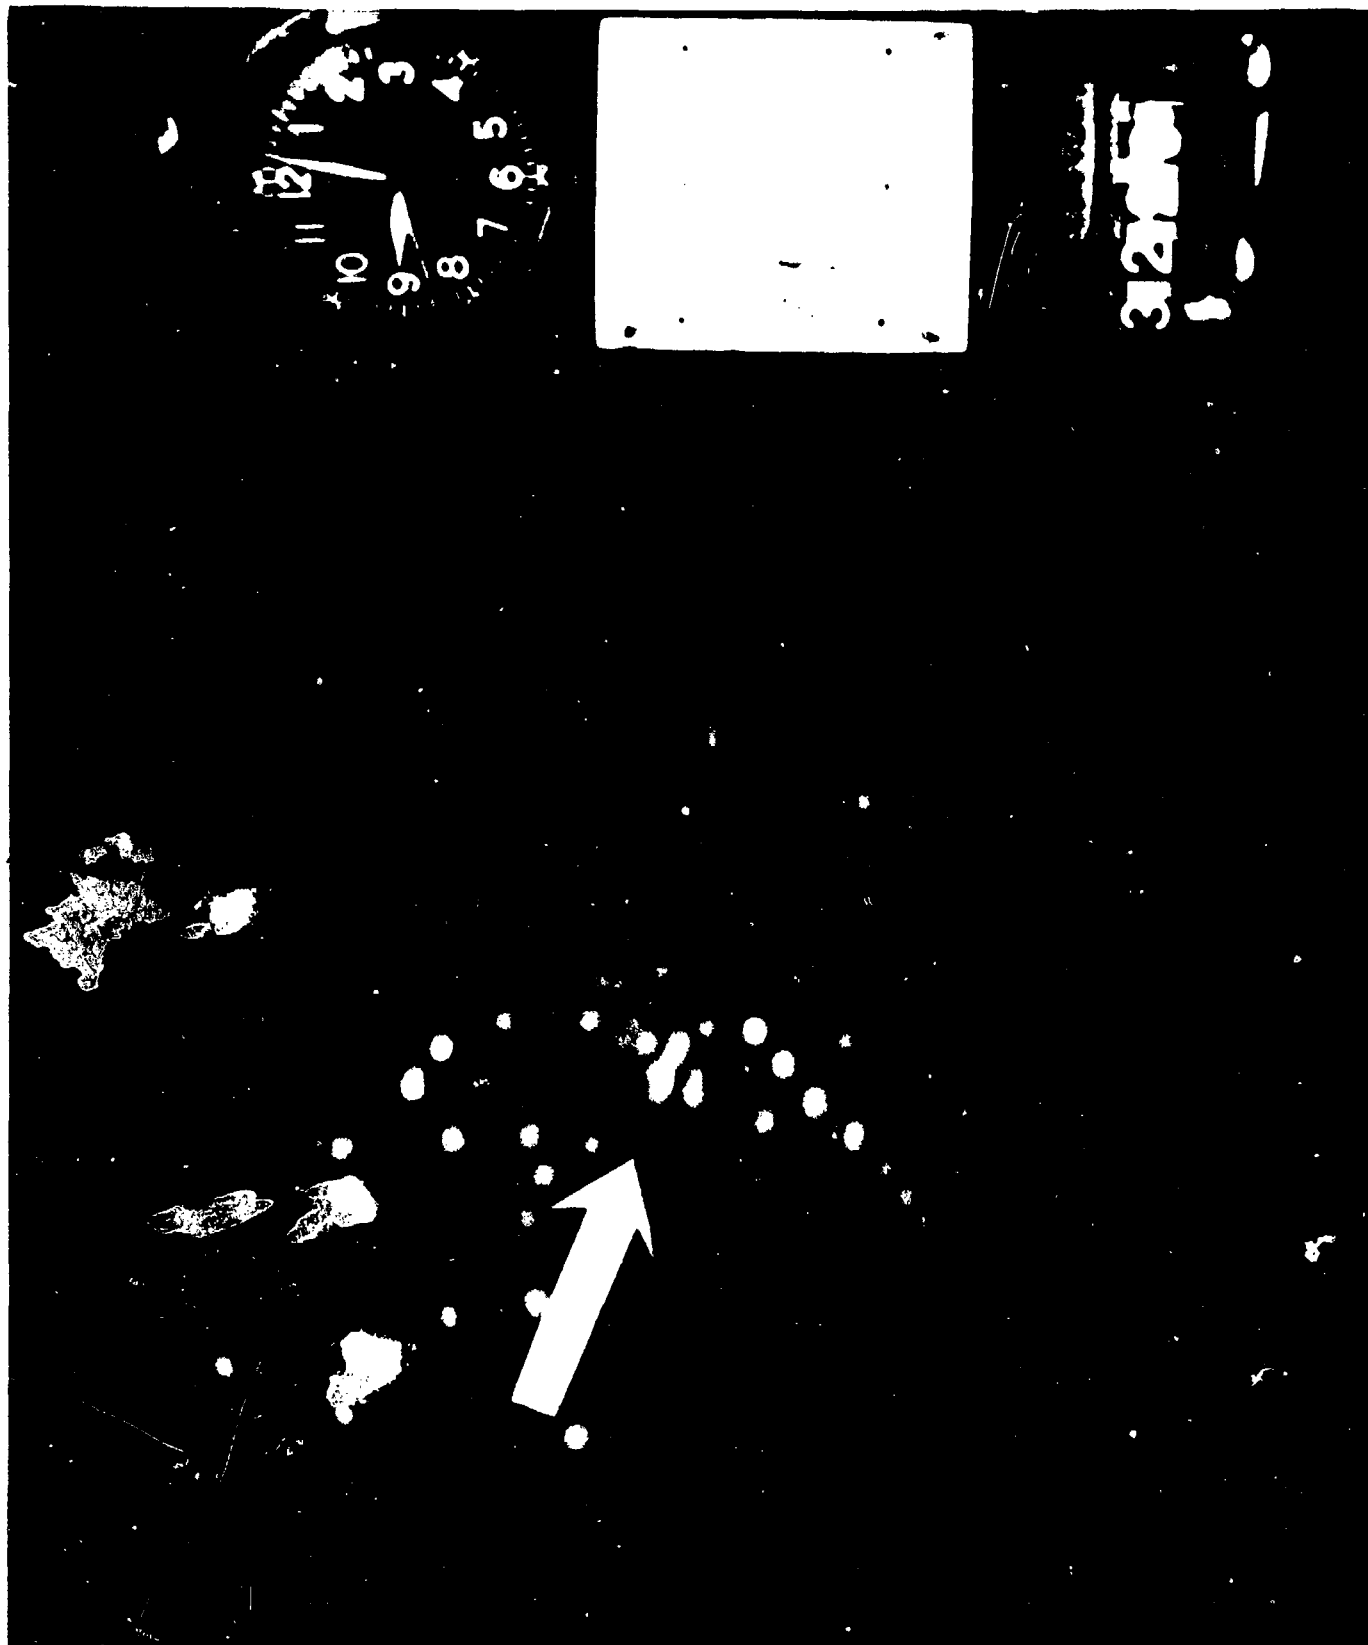
APQ #7 radar scope photo #3320. View of radar scope taken 2 minutes 38 seconds after blast. Note ANDERSON has disappeared.

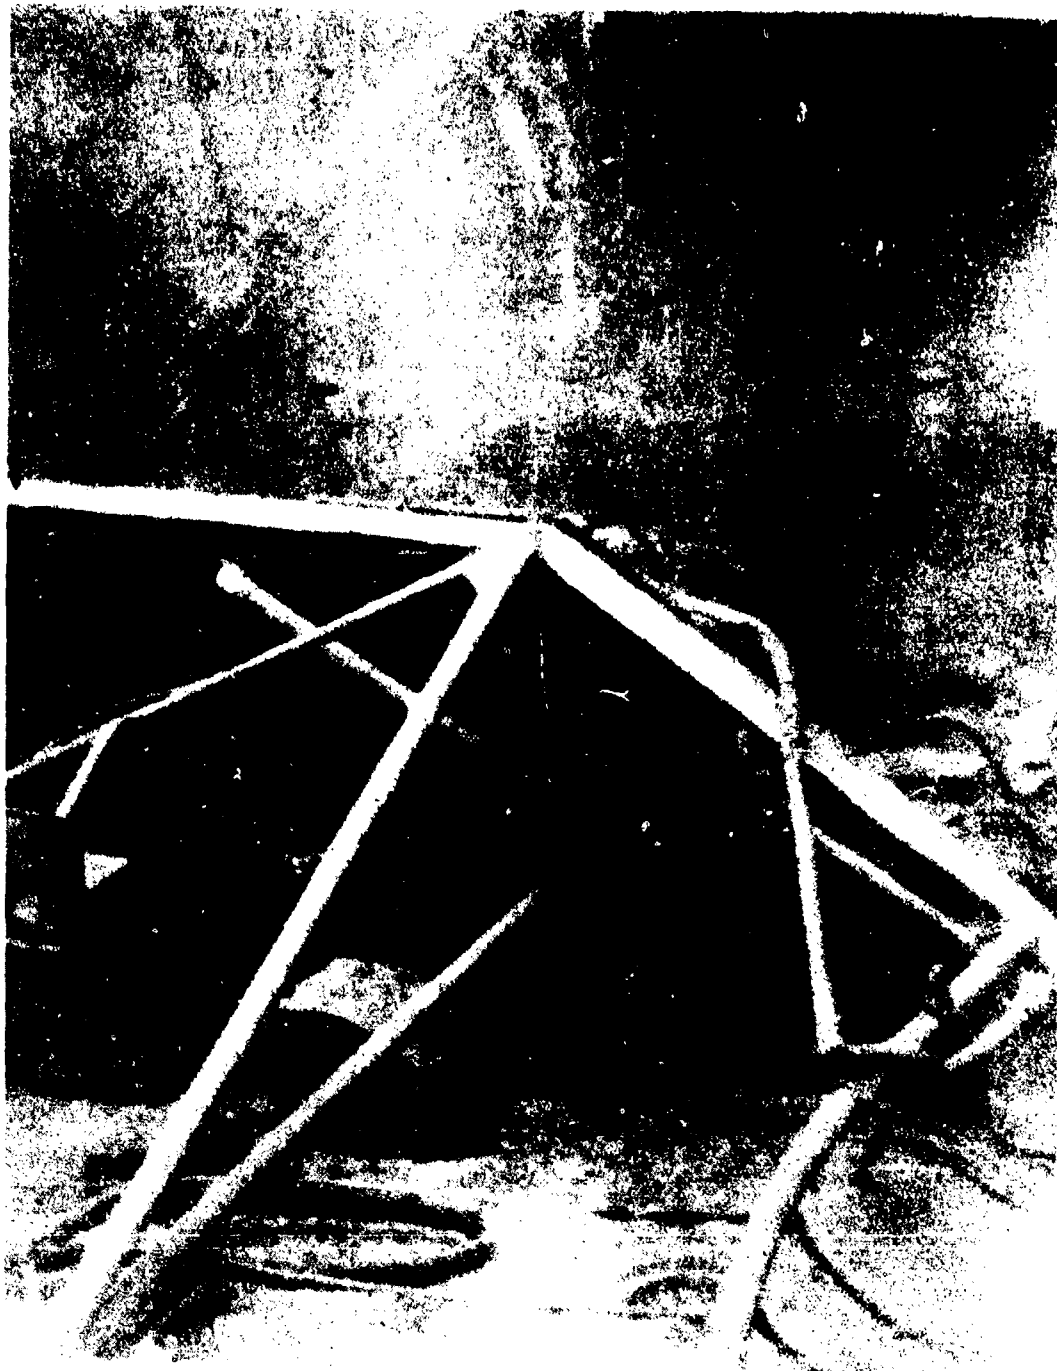
CR-5-S27-3 (Underwater). Underwater view showing bulwark plating of ANDERSON missing aft of frame 105 starboard.
